# **Harrow Flood Investigation Final Report**

**June 2017**

| Project Name | Harrow Flood Investigation |
| Client | Glenelg Hopkins CMA |

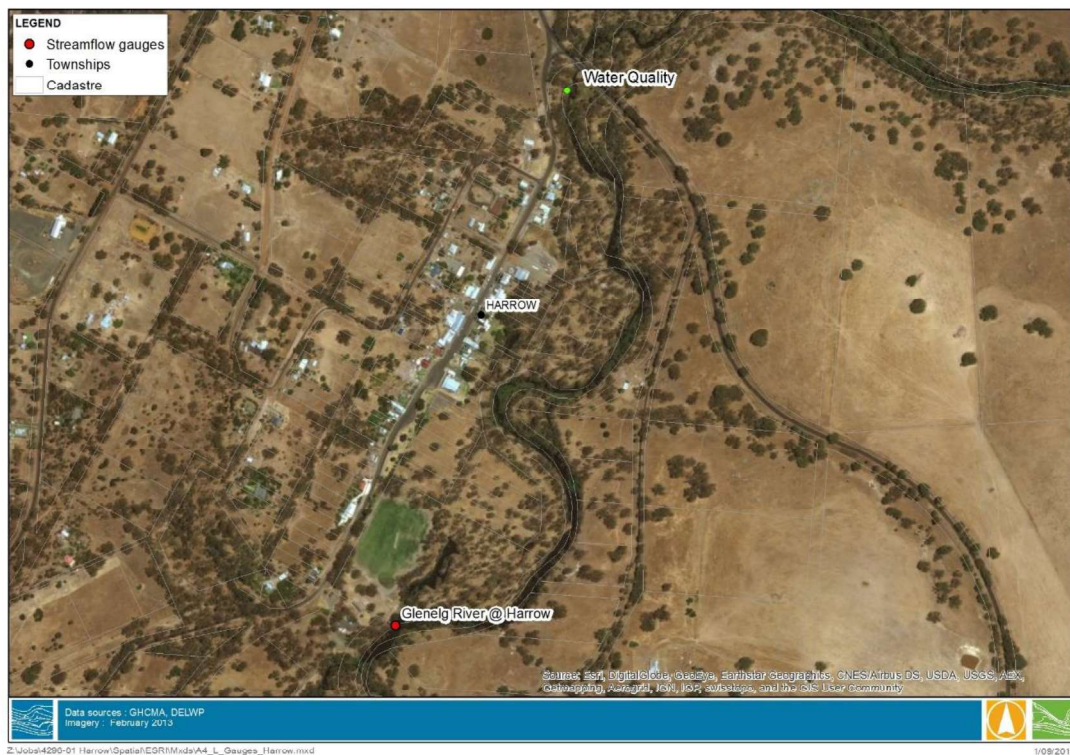
**Figure 3-4 Harrow streamflow and water quality gauge locations**

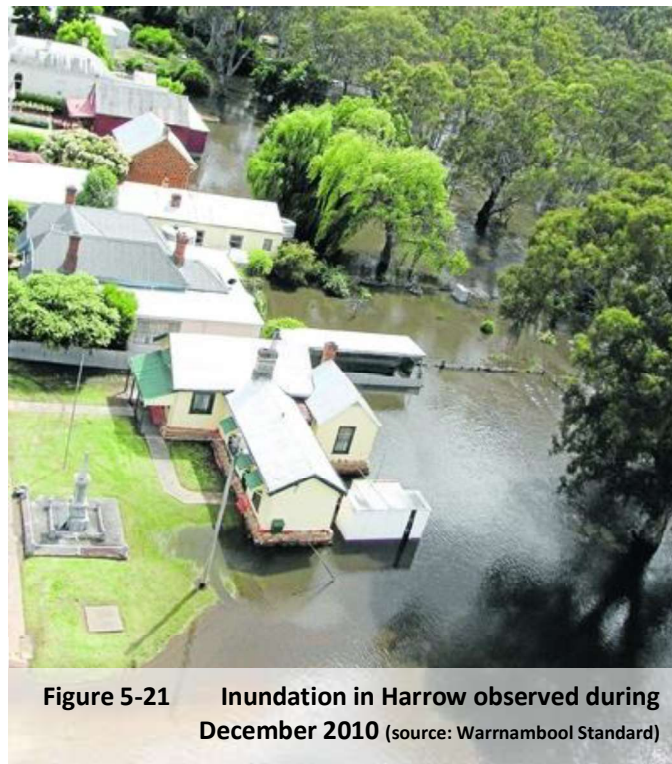
Significant inundation was observed in the Harrow township with several buildings flooded below floor. There were seven peak flood heights surveyed of the December 2010 event in Harrow, these points were used for the hydraulic model calibration. An aerial photo capturing the inundation in Harrow during December 2010 is shown in Figure 5-20.

**Figure 5-21** Inundation in Harrow observed during December 2010 (source: Warrnambool Standard)
